**Subject: Annual Inspection Report
Albertville Regional (Thomas J. Brumlik Field) Airport**

ANNUAL INSPECTION REPORT

July 20, 2011

ALBERTVILLE REGIONAL AIRPORT
(THOMAS J. BRUMLIK FIELD)
ALBERTVILLE, ALABAMA

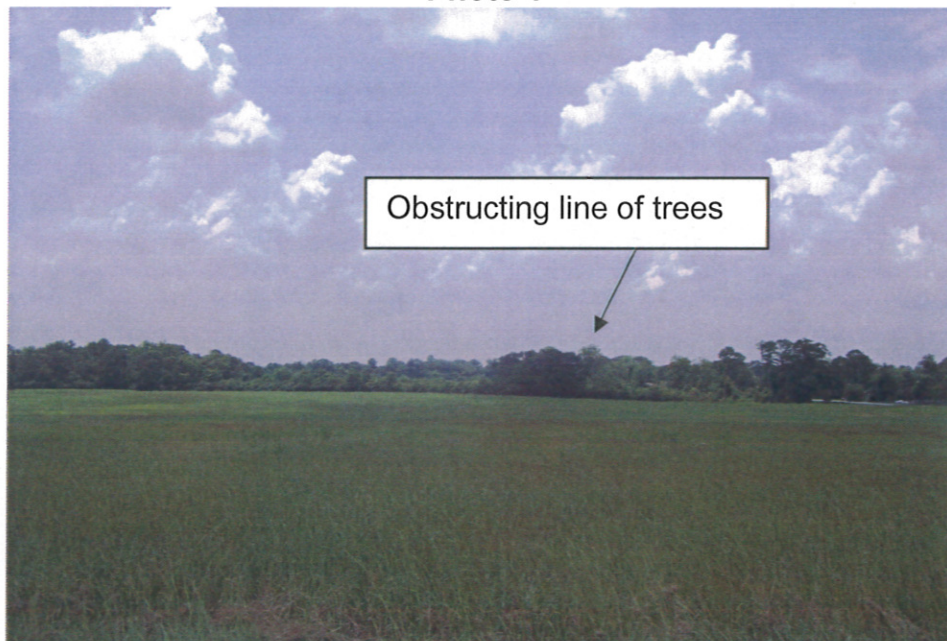
Photo 1

- Runway 5 – The FAR Part 77 34:1 approach slope is violated by trees 1119 feet from the runway end. The approach is limited to 24:1.

Runway 5 approach

- Remove all obstructions within the FAA Runway Protection Zone to accomplish an unobstructed 34:1 slope. The most recent Airport Layout Drawing shows the property on which the trees are situated is to be acquired and the trees removed.

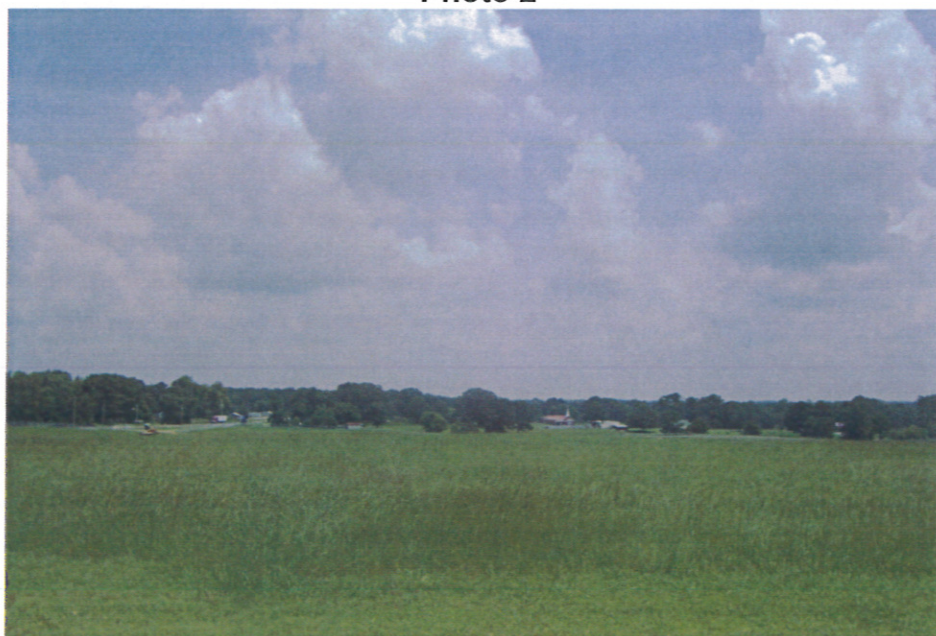
Photo 2

- The Approach/Departure Paths of both runways are unobstructed and meet licensing requirements.

Approach to Runway 23

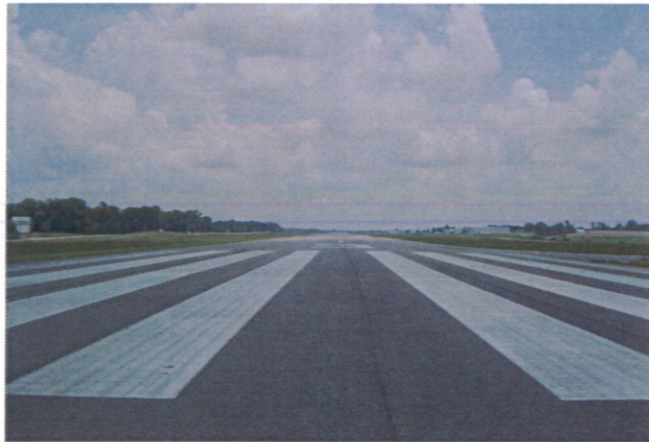
Photo 3

- The markings of the airport are in GOOD condition.

Runway Identifier markings of Runway 5

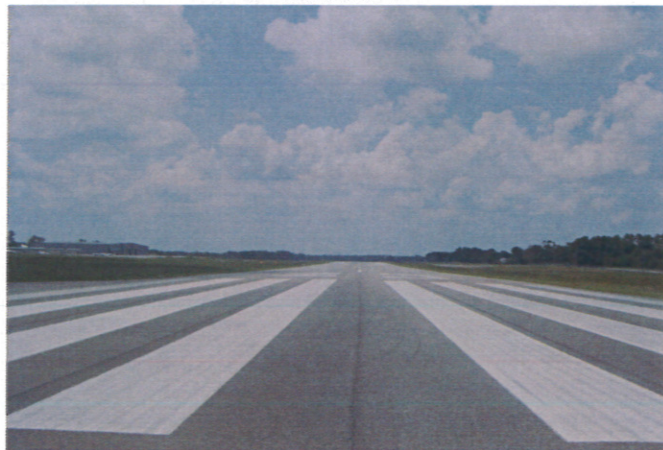
Photo 4

Runway Identifier markings of Runway 23

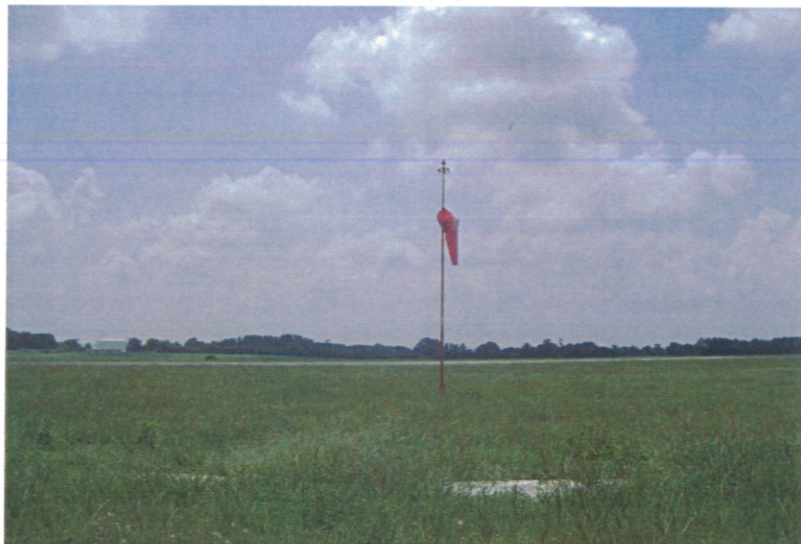
Photo 5

- The wind direction indicator (windsock) was inspected and found to be operational.

Windsock assembly and segmented circle

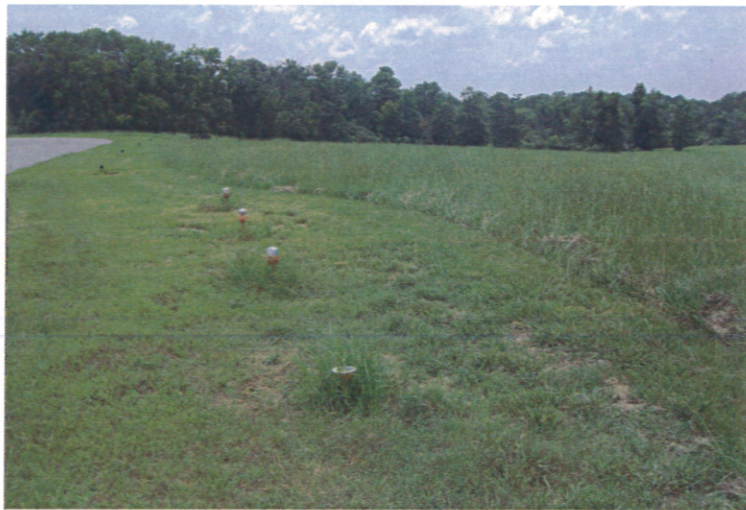
Photo 6

- The airport lighting system was inspected and found operational.
- **Maintenance** – One threshold light globe is missing on Runway 23
One taxiway globe is missing

Missing threshold globe

- Replace missing globes

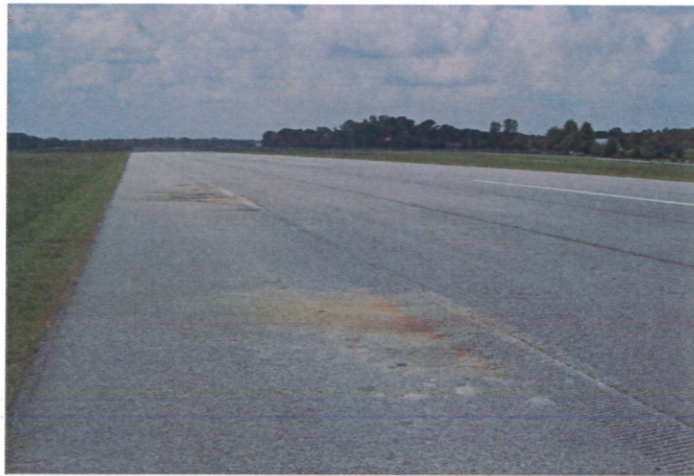
Photo 7

- The airport surface overall was found to be in excellent condition, however there is water seeping through the pavement along the outside paving lanes particularly along the southern outside paving lane near Runway 5.

Water seepage through runway pavement

- The condition of the areas shown above suggests a saturated base beneath the surface. If the saturation continues it could lead to premature failure of the base and the asphalt.
- The engineer for the airport should be consulted to determine if underdrains should be considered for the runway.

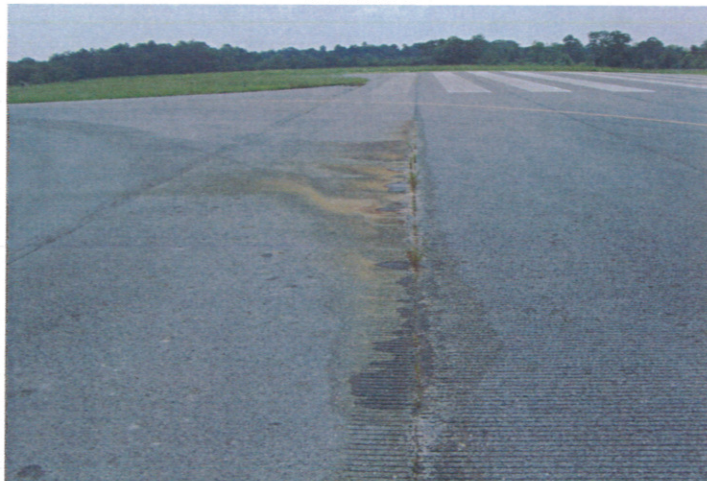
Photo 8

Water seepage along runway edge at taxiway connector

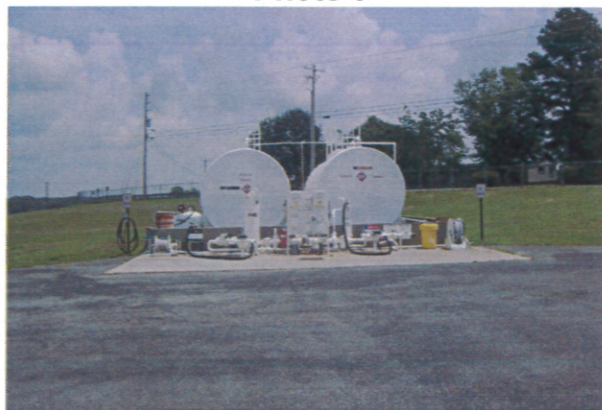
Photo 9

- The fueling area meets the requirements established by the Alabama Department of Transportation. However, the State of Alabama Department of Agriculture and Industries may have additional requirements for fueling systems that were not considered during this inspection.

Fueling area

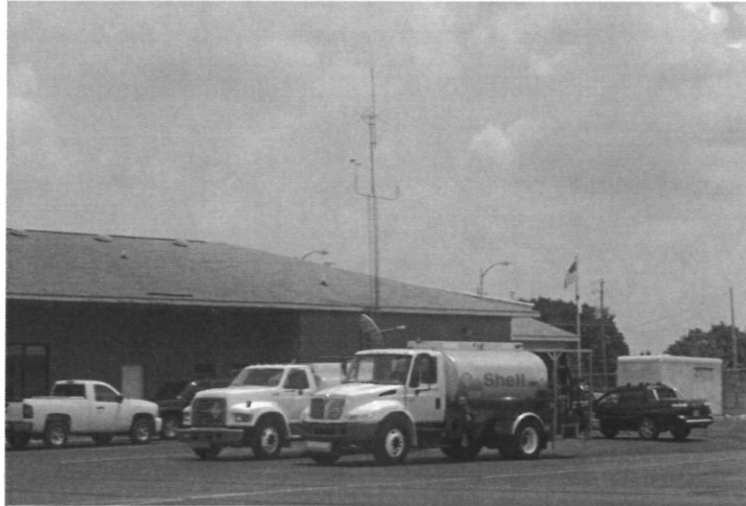
Photo 10

Fuel trucks
